Environmental and Social Impact Assessment for the Proposed Karuma – Gulu Water Supply Project

Reference Number: NWSC-HQRS/SRVCS/17-18/163587

NATIONAL WATER & SEWERAGE CORPORATION

AWE Environmental Engineers

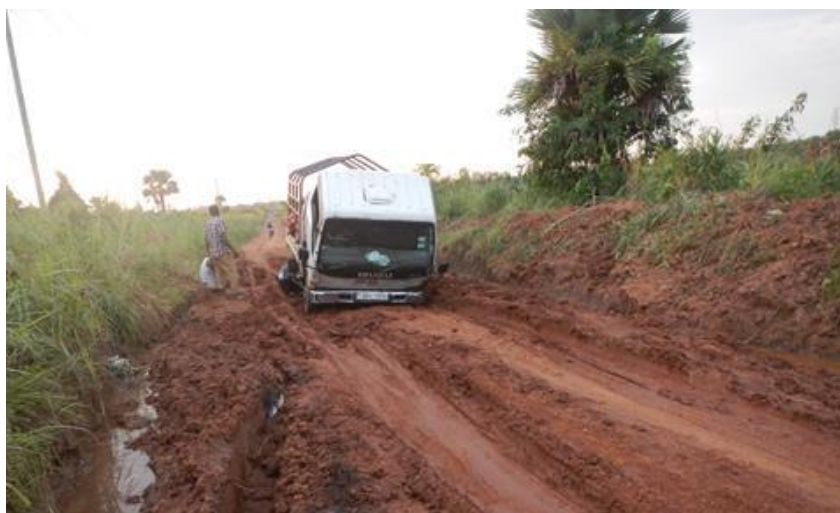
Photo 55: State of one of the community roads after a heavy rain

Significance of impact: Since the duration of the impacts is short- term the **intensity** of the impacts is considered to be '**medium**'. The receptor **sensitivity** is considered to be '**high**' in terms of deterioration given the vulnerability of such roads and access routes for the communities to and around the proposed project area and given the some of the roads in Gulu Municipality and the Karuma – Gulu Highway have just been resurfaced. The impact significance is therefore **major**.

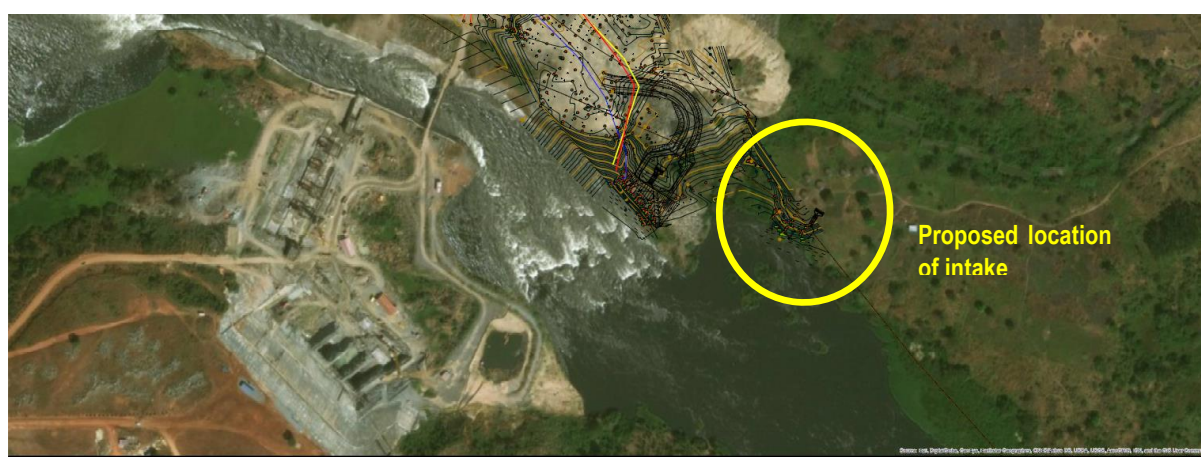
Figure 55 Proposed location of the intake at the northern bank of the Victoria Nile
